ASIRT DECISION

**IN THE MATTER OF A POLICE DOG BITE IN CALGARY
ON FEBRUARY 12, 2025**

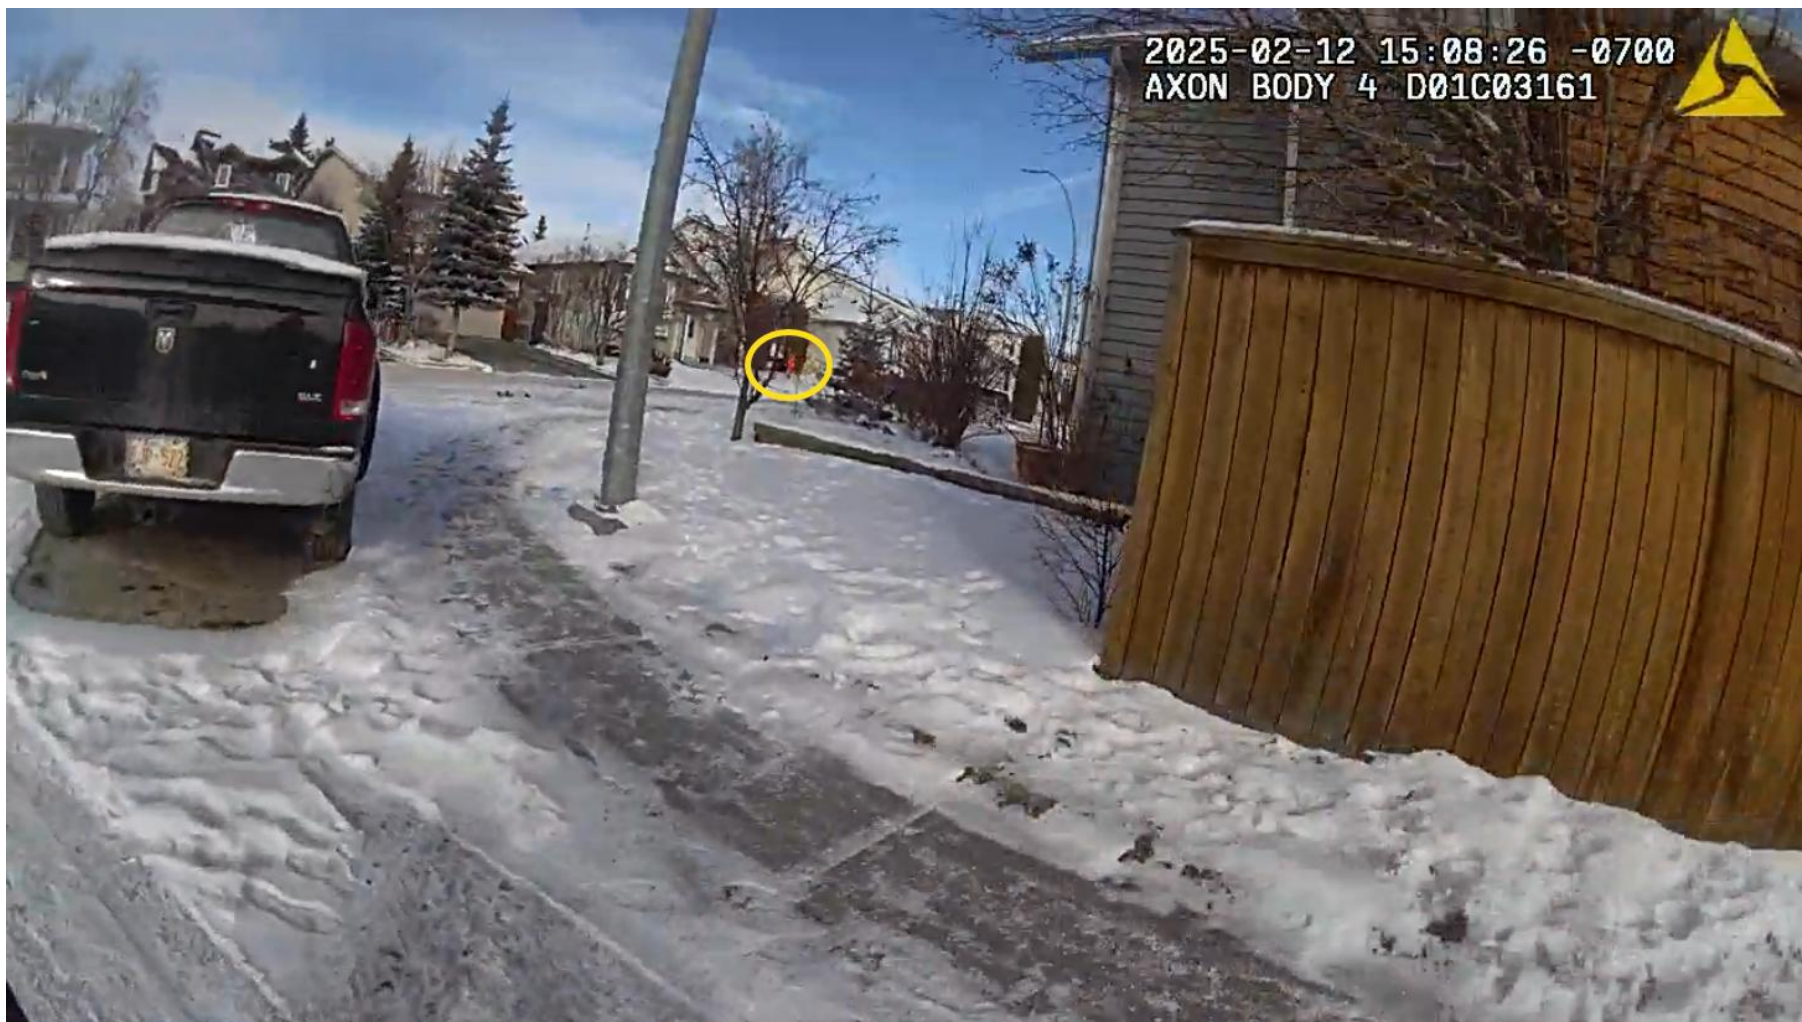
Figure 2 - The SO observed the suspect (circled in yellow) as he was running towards the side of a residence. Image sourced from: SO's BWC.

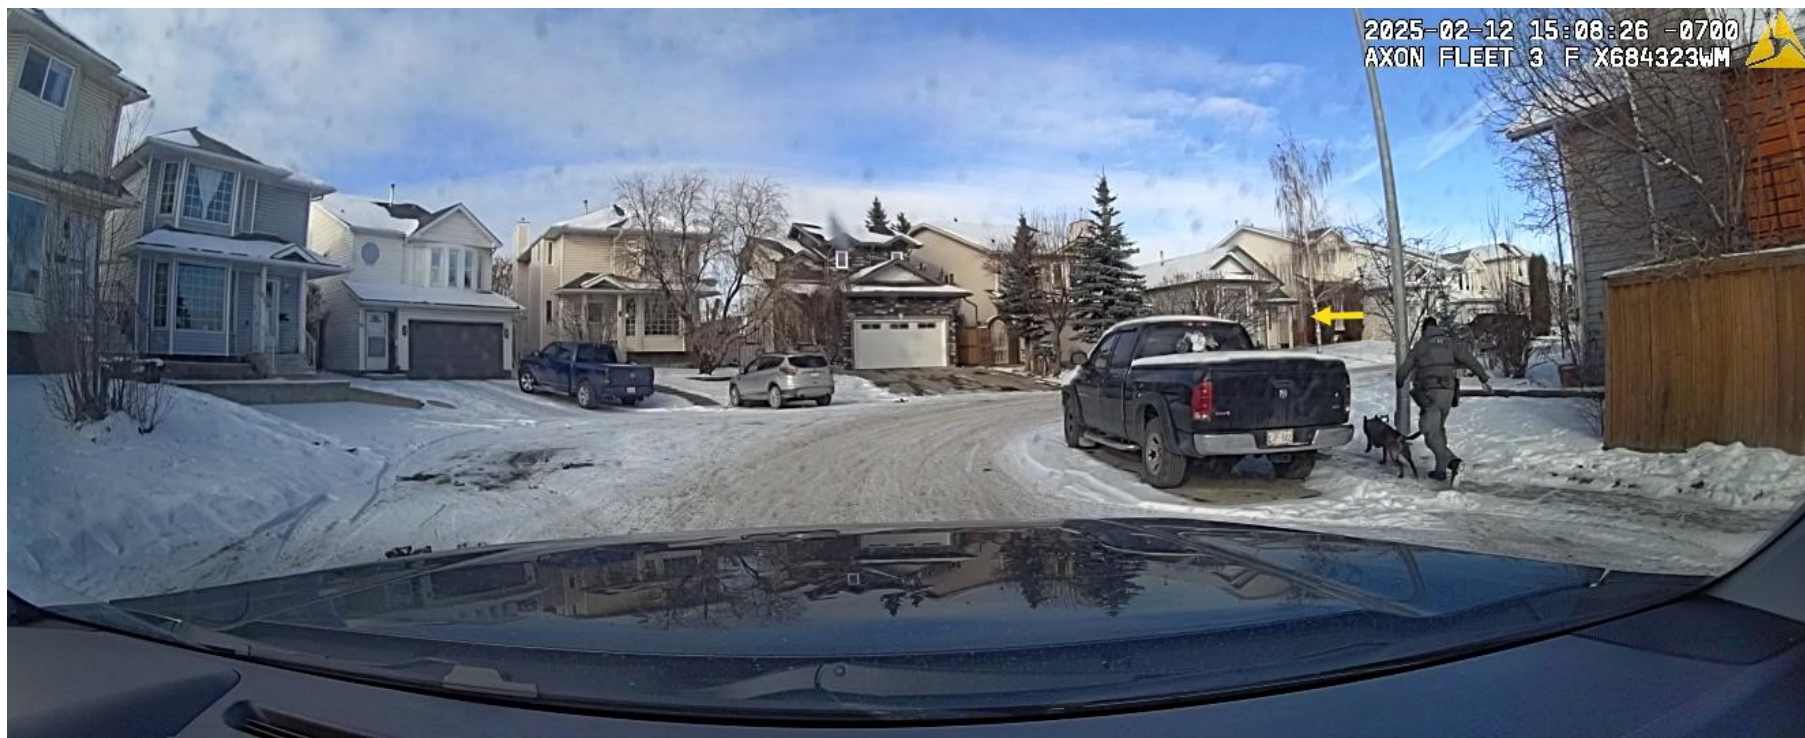
Figure 3 - The SO released his PSD just as the suspect ran between residences. The yellow arrow indicates the suspect's location and direction just prior to disappearing from view. Image sourced from: WatchGuard video from the SO's police vehicle.

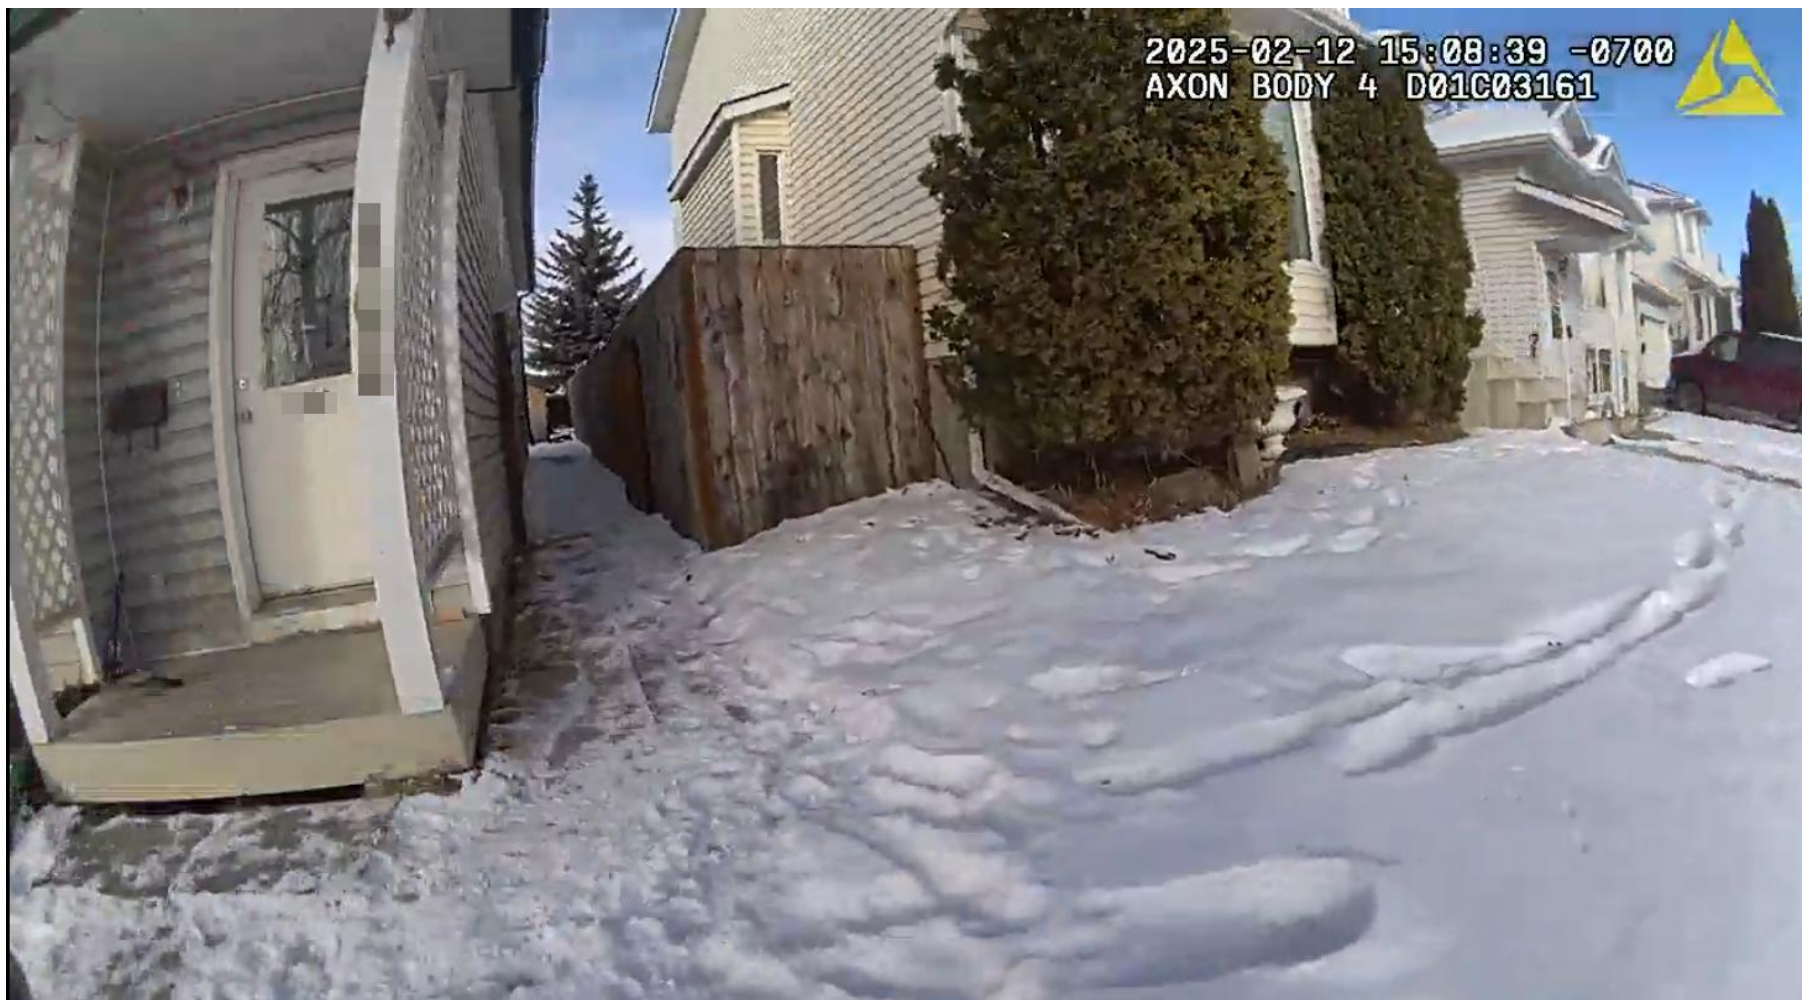
Figure 7 - The SO entered the passage on the east side of the residence where his PSD and the suspect had previously fled. The PSD is not visible in the image as the PSD has already made it beyond the back fence as reflected in Figure 6. Image sourced from: SO's BWC.

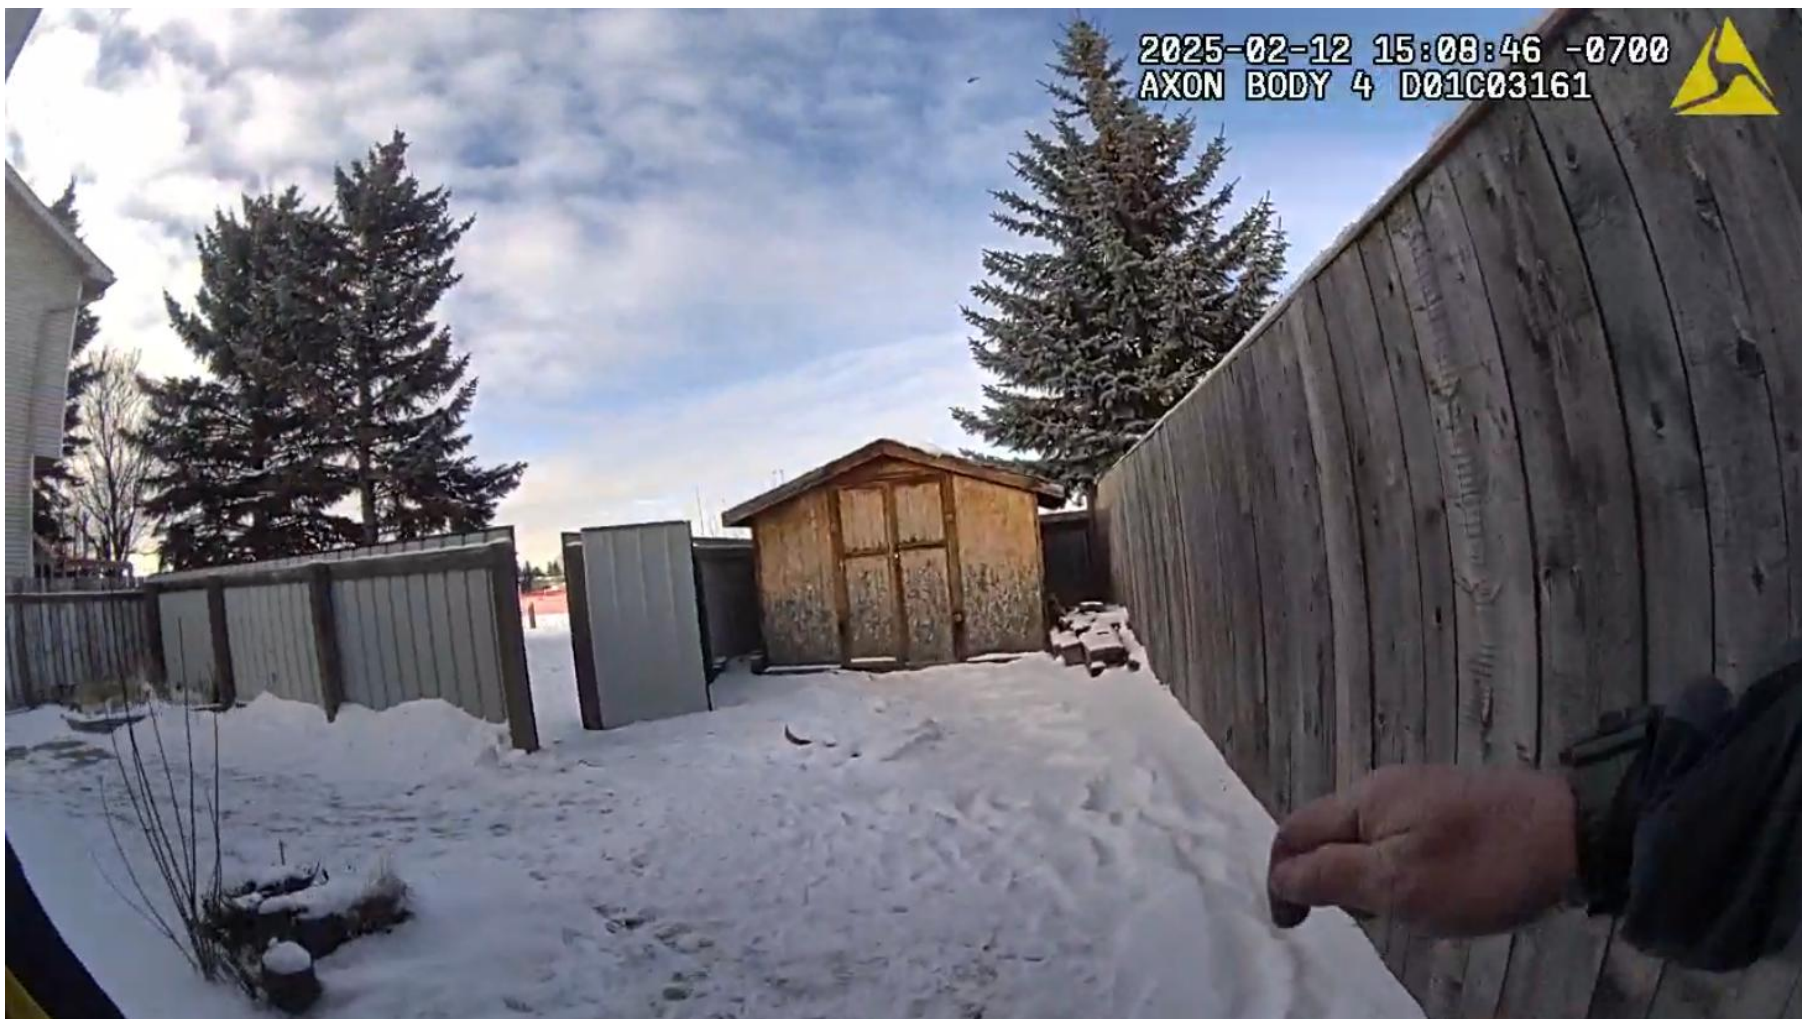
Figure 8 - The SO ran into the backyard of the residence. The open gate which leads to an alley and the greenspace beyond the backyard is seen. The PSD is not visible. Image sourced from: SO's BWC.
